BLACKSTONE RIVER BASIN
MILLBURY, MASSACHUSETTS

SINGLETARY POND DAM
MA 00144

PHASE I INSPECTION REPORT
NATIONAL DAM INSPECTION PROGRAM

FEBRUARY 1979

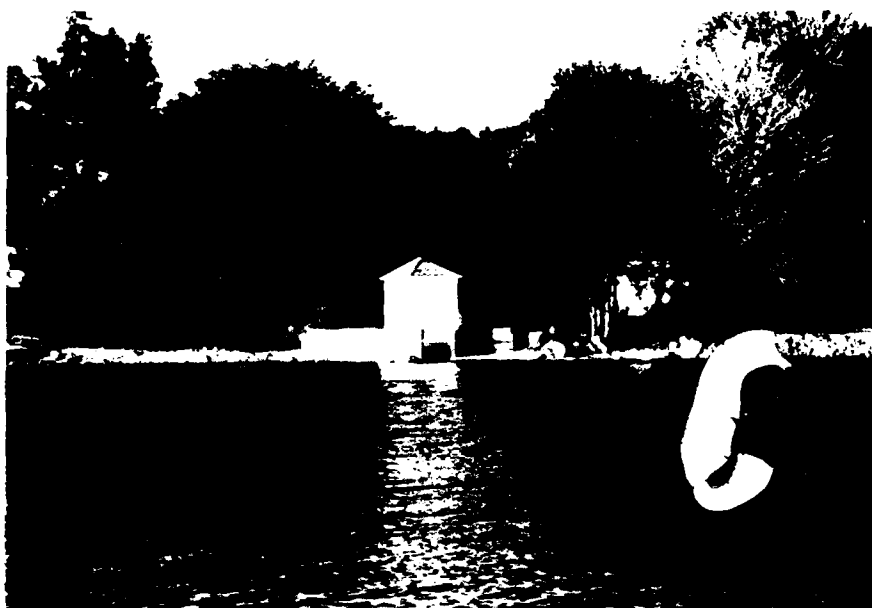
1. TELEPHOTO OVERVIEW OF UPSTREAM FACE OF DAM AND INTAKE GATE HOUSE.

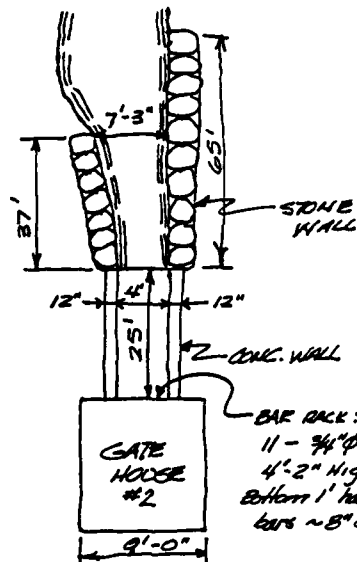
BAR RACK:
11-3/4" high
4'-2" wide
Bottom 1' has only 6-3/4" bars ~8" OC.

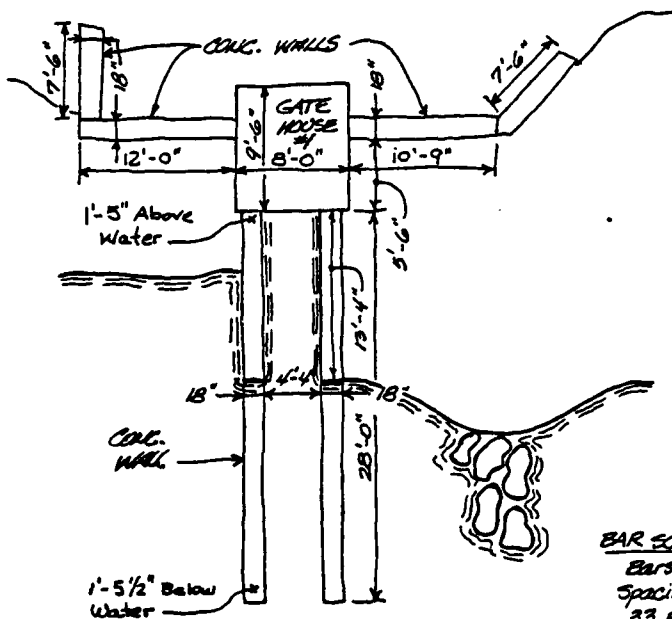
BAR SCREEN
Bars: 2 1/2" x 1/4"
Spacing: 1 1/2"
33 Bars Total

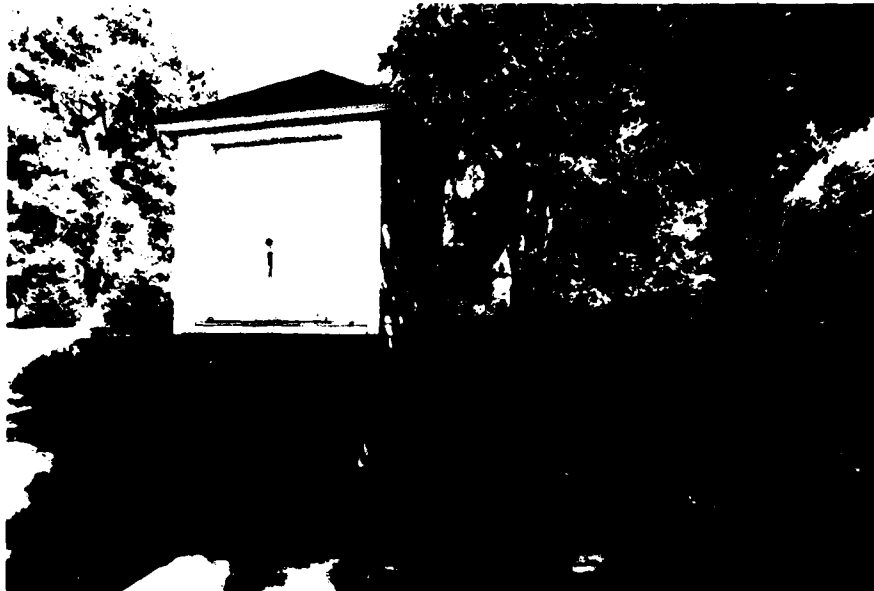
2. INTAKE CHANNEL AND UPSTREAM FACE OF INTAKE GATE HOUSE.

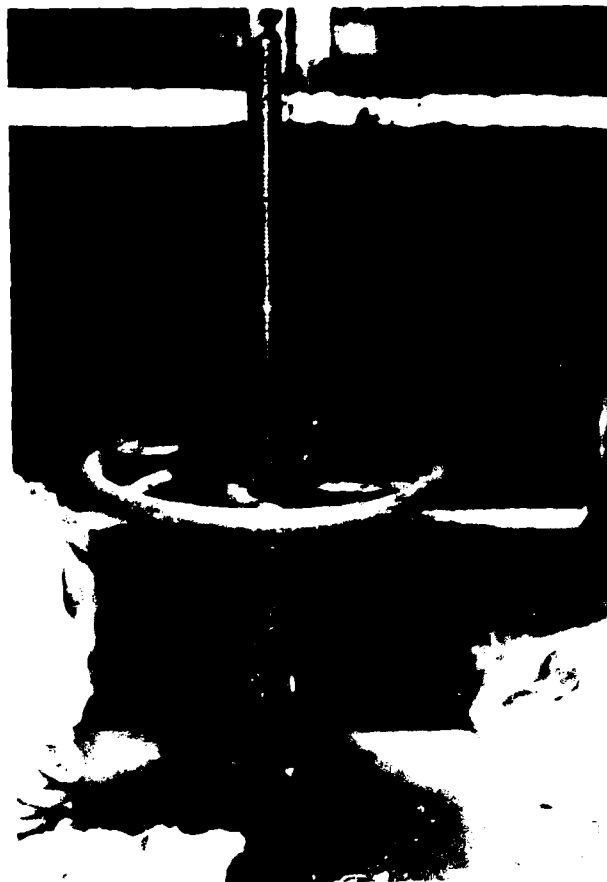
8. GATE OPERATOR IN INTAKE GATE HOUSE.
